Hazard Profile – Landslide

Summary

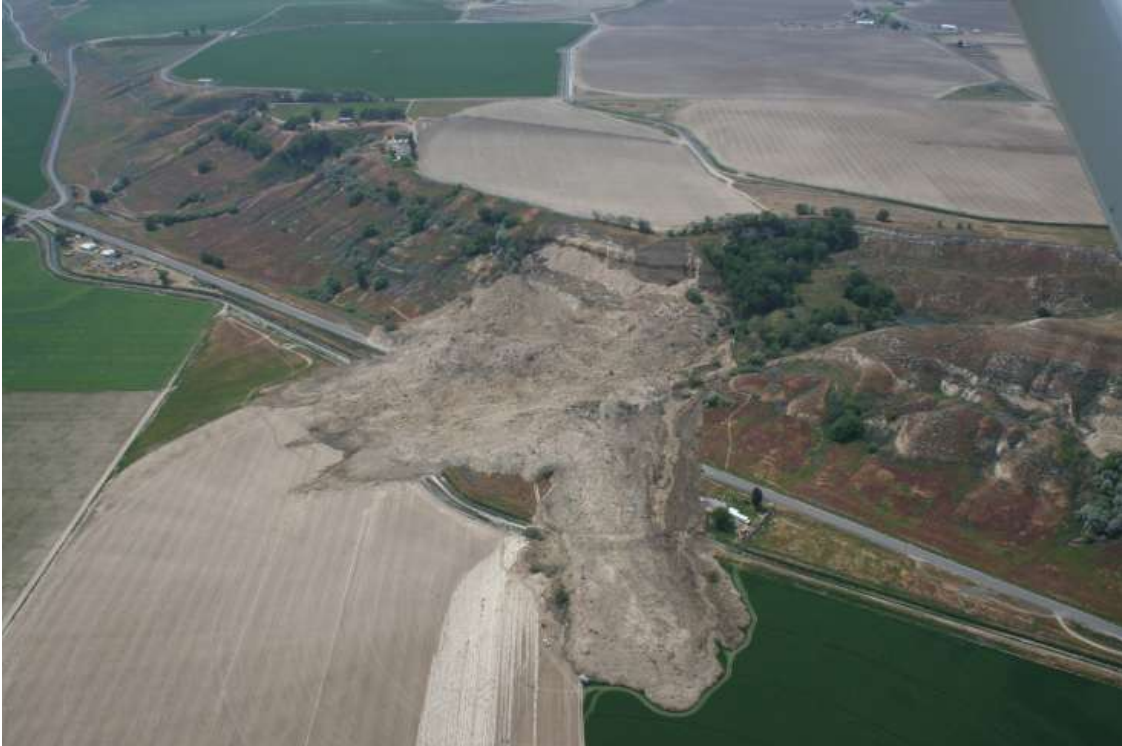
Figure 1. At about 9 p.m. on Saturday, May 13, a large section of bluff sloughed off and covered about a quarter-mile of Road 170 between Klamath and Sheffield roads to a depth of about 40 feet. The slide destroyed a grain bin, damaged power lines and an irrigation circle, and narrowly missed a mobile home. It also choked an irrigation canal, cutting off water to about 20 landowners. A similar landslide happened in almost the same spot about 25 years ago. Photo courtesy of the South Columbia Basin Irrigation District.

- May – At about 9 p.m. on May 13, a large section of bluff on Basin Hill moved and covered about a quarter of a mile of road 170 between Klamath and Sheffield roads, to a depth of up to 40 feet in places. The landslide destroyed a grain bin, damaged power lines and an irrigation circle, and narrowly missed a mobile home. The landslide also blocked an irrigation canal, cutting off water to about 20 landowners and as much as 2,000 acres of farmland. A similar landslide occurred at this spot about 25 years ago.

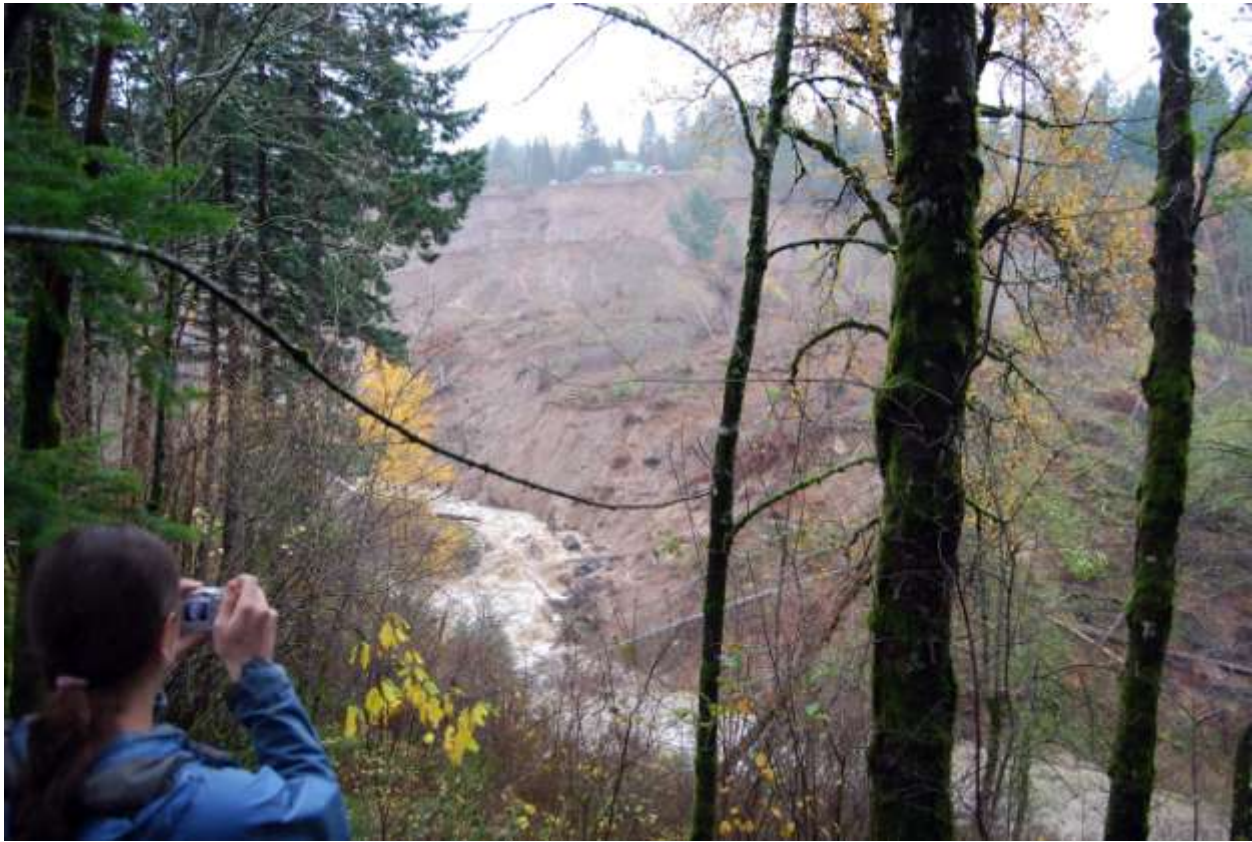
Figure 2. Landslide at Rock Creek north of Skamania, taken on November 16, 2007.

- February – In Skamania County, in the town of Stevenson, a landslide was starting to show cracks in the hillside along Rock Creek in early February. The landslide accelerated in movement and expanded in size, eventually displacing or destroying two houses. The landslide probably formed by prolonged rains in the area in November of 2006. Downstream of the landslide, in the City of Stevenson, debris has clogged Rock Creek, threatening to destroy a bridge (with utilities) and threatening the cities sewage treatment plant. As of Oct. 2009, the landslide has slowed in movement and has not expanded any further.
- During a prolonged cold spell east of the Cascade Mountain Range, a large rockfall event closed one lane of State Route 20 in the vicinity of MP 301.8 for two days, just west of Republic.

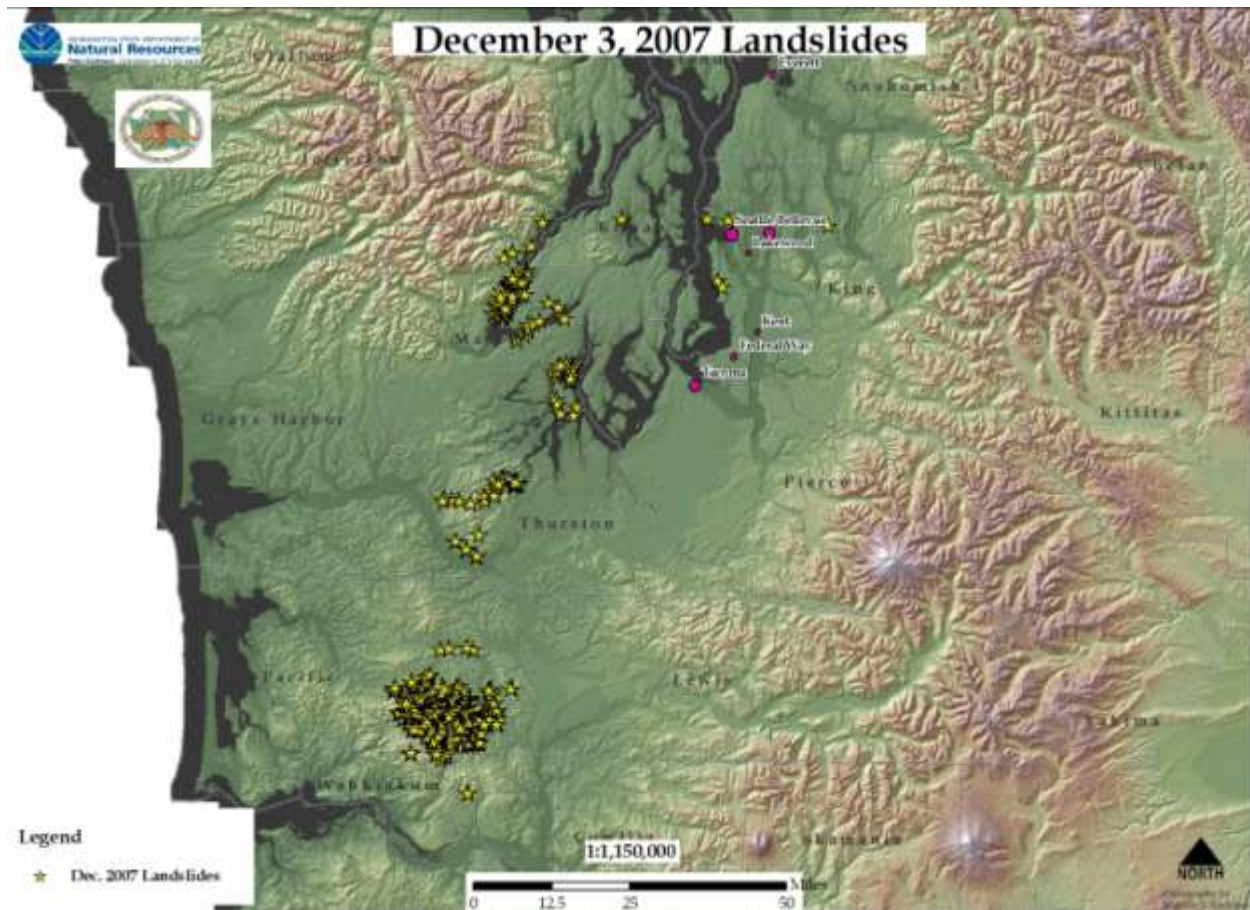
Figure 3. Landslide initiation points from the December 3, 2007 Storm

Landslides blocked or damaged roads, isolating communities in the height of the storm and delaying emergency response. At least one person died as a consequence of the storm. The precipitation was mostly concentrated on the western side of Puget Sound and created a band of landslides from Mason County to Jefferson County. Just west of Pe Ell (Lewis County), a massive debris avalanche along with numerous smaller landslides blocked State Route 6, from Pe Ell to Raymond, isolating 21 households without electricity and water. In addition, State Route 8, just west of the SR 101 interchange in the vicinity of MP 18, State Route 12 in the vicinity of MP 27 between Porter and Malone, and SR 508 near Onalaska were blocked by landslides.

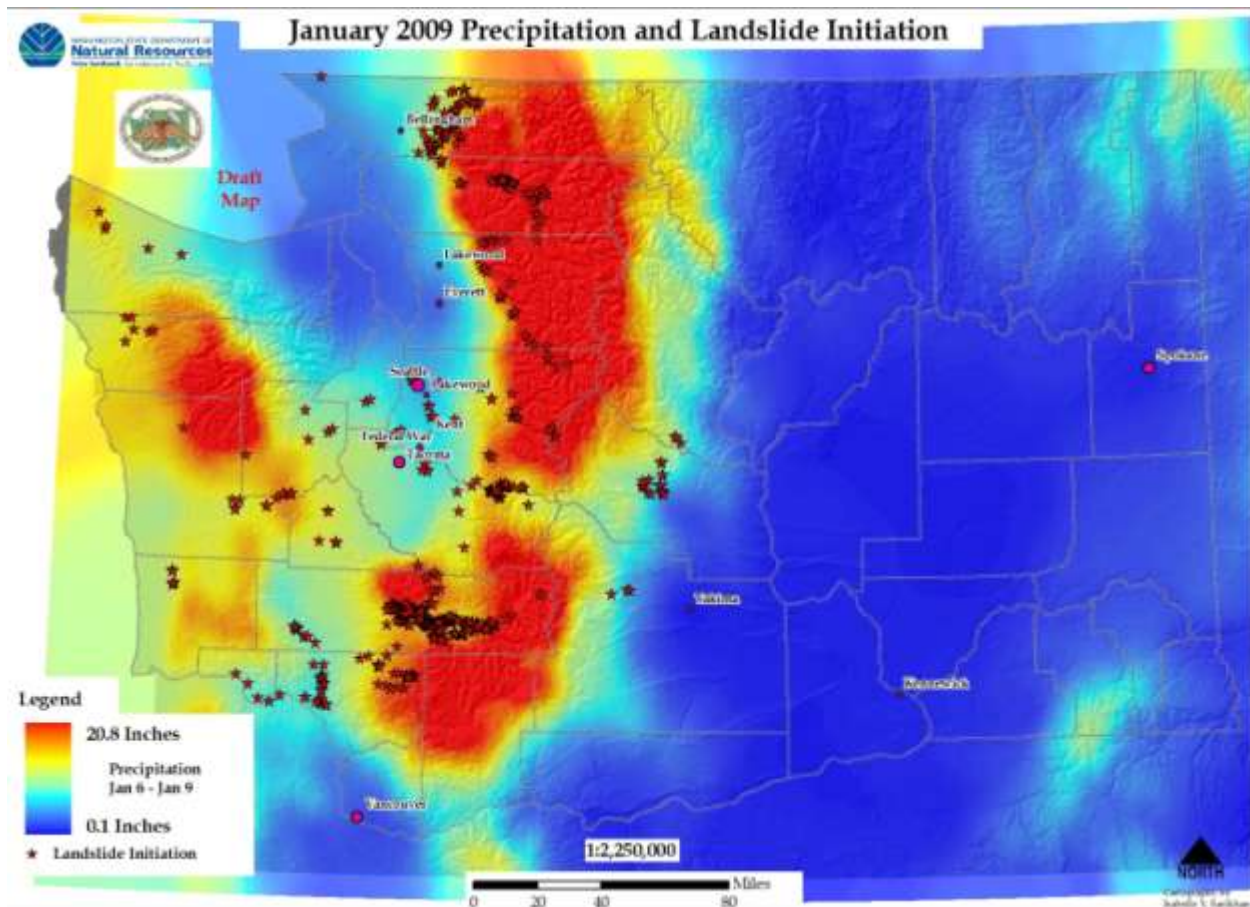
Figure 4. January 7-8, 2009 storm and landslide initiation.

In Lewis County, hundreds of debris flows between Morton and Randle flowed into the valley, destroying houses and blocking Highway 12. The debris flows were very long reaching, often transforming into hyperconcentrated flows on the valley floor and moving for miles downstream. Many of the hyperconcentrated flows were channelized into roadways by plowed snow from earlier snow storm events. Over 500 landslides were recorded in Eastern Lewis County with an unknown number of houses damaged. No deaths were reported.

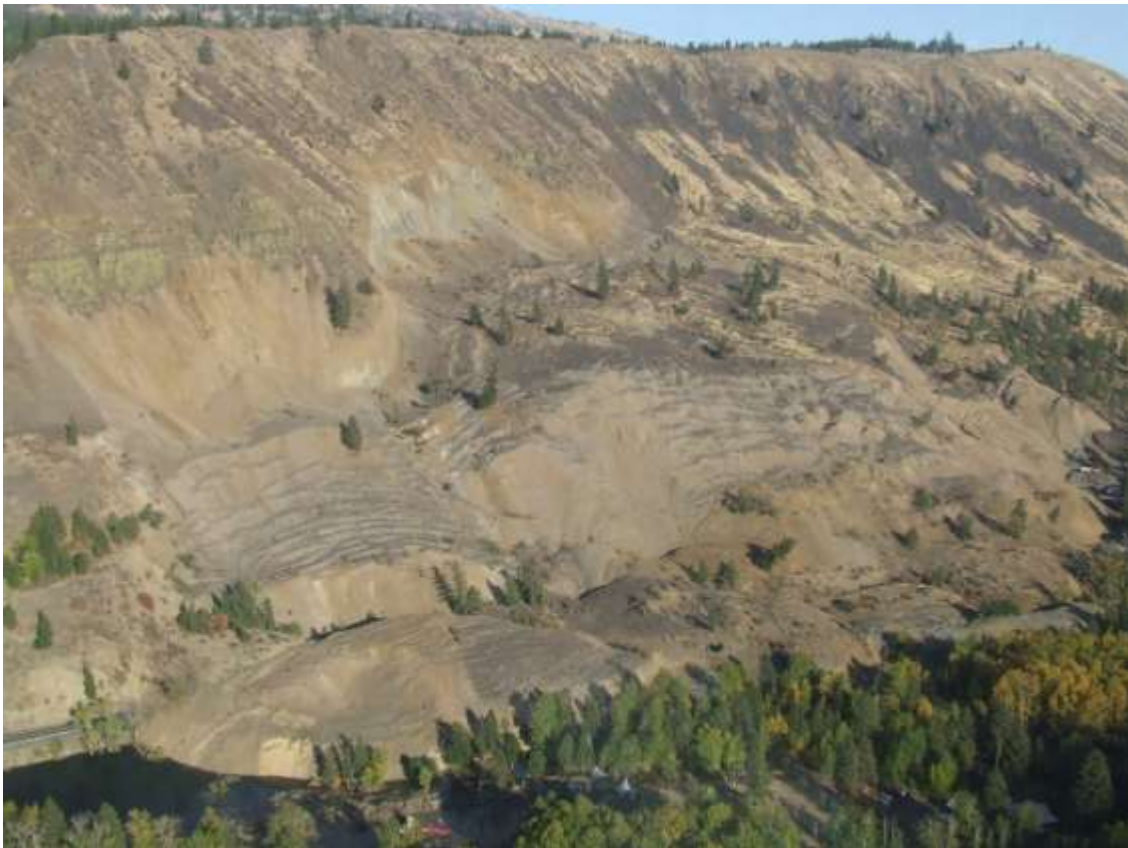
Figure 5. An oblique photo of the Nile Landslide, photo by Jack Powell, DNR

- July – A debris flow on July 29 closed the North Cascades Highway near Rainy Pass. The landslide was triggered following several days of thunderstorms. The landslide was reported to be about 900 feet long by about 10 feet deep along the Highway.
- August – An abutment along a railroad track in Stevens County gave way on August 6, resulting in a small landslide. A train was derailed as a result of the damaged railroad tracks. On August 25, a landslide on the Spokane River arm of Lake Roosevelt resulting in an inland tsunami. The tsunami damaged the Porcupine Bay Campground and injured two children.
- October – A massive landslide started to move on October 10 west of Naches near the town of Nile. On October 11, the landslide catastrophically failed, diverting the Naches River covering Highway 410, and damaging 6 houses by ground deformation and over 20 by flooding.

Following the landslide movement Yakima County purchased 60 acres of land that included several homes at a cost of \$1.78 million to realign the Naches River channel and a new road. WSDOT constructed a temporary route for Highway 410 on the other side of the valley. In response to the danger of the landslide, WSDOT, DNR, and the University of Washington monitored the landslide for

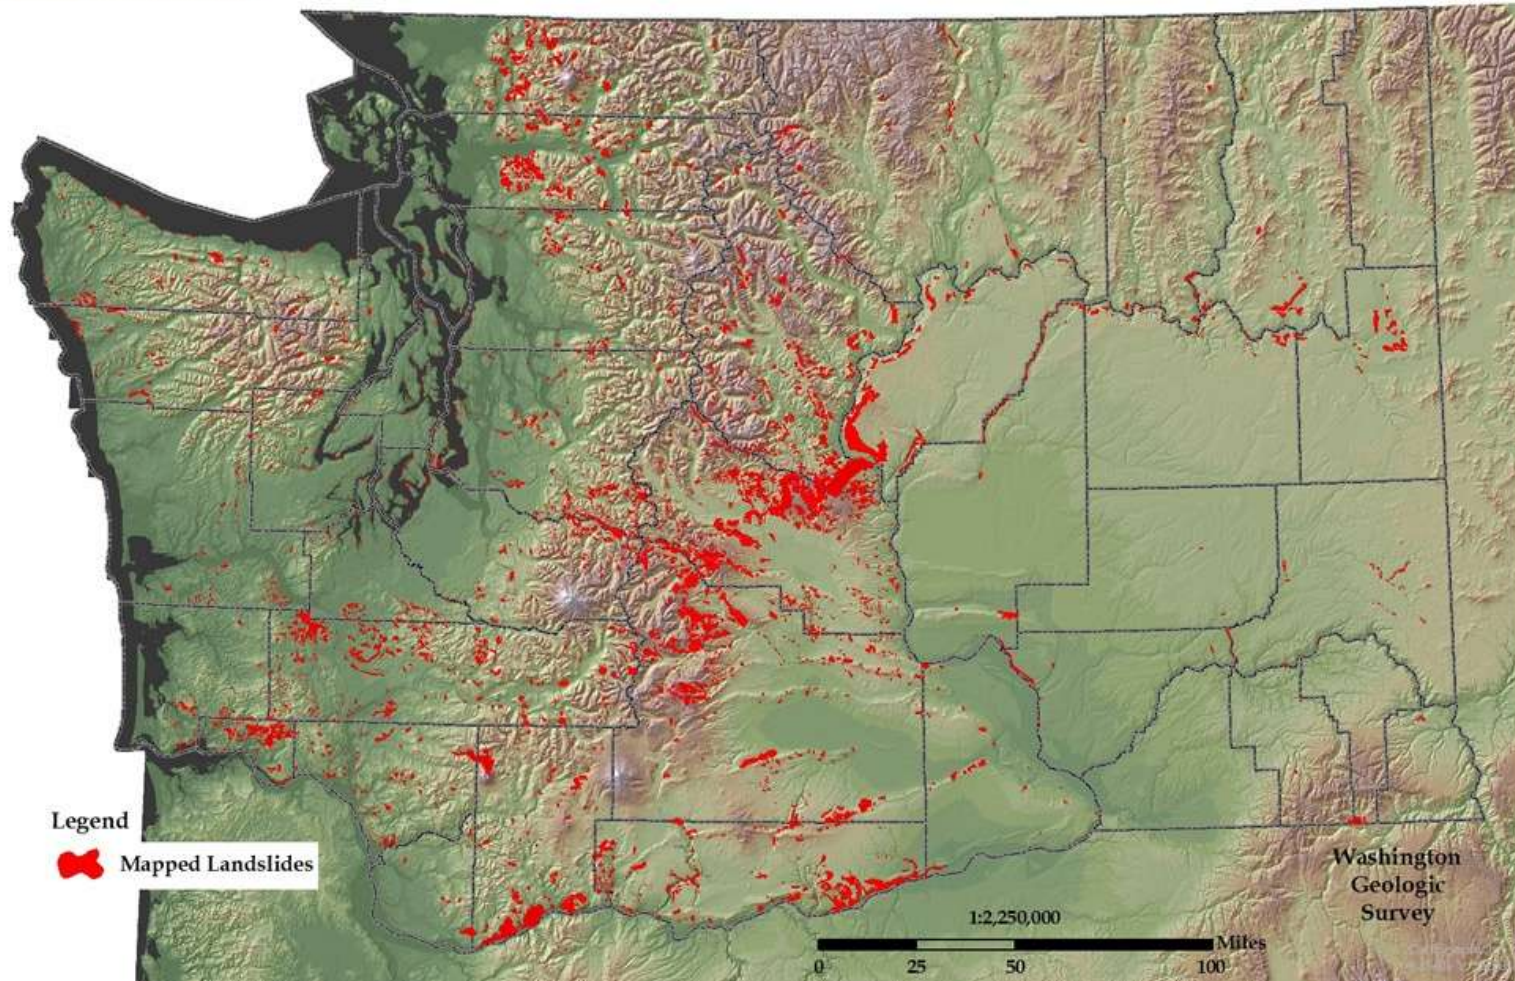
Washington Geologic Survey Landslide Database

Figure 6. The Washington Geologic Survey's statewide landslide database, representing both 100k and 24k landslides. This database is only a partial representation of landslides in Washington State and does not represent all landslides within Washington State. (2009)

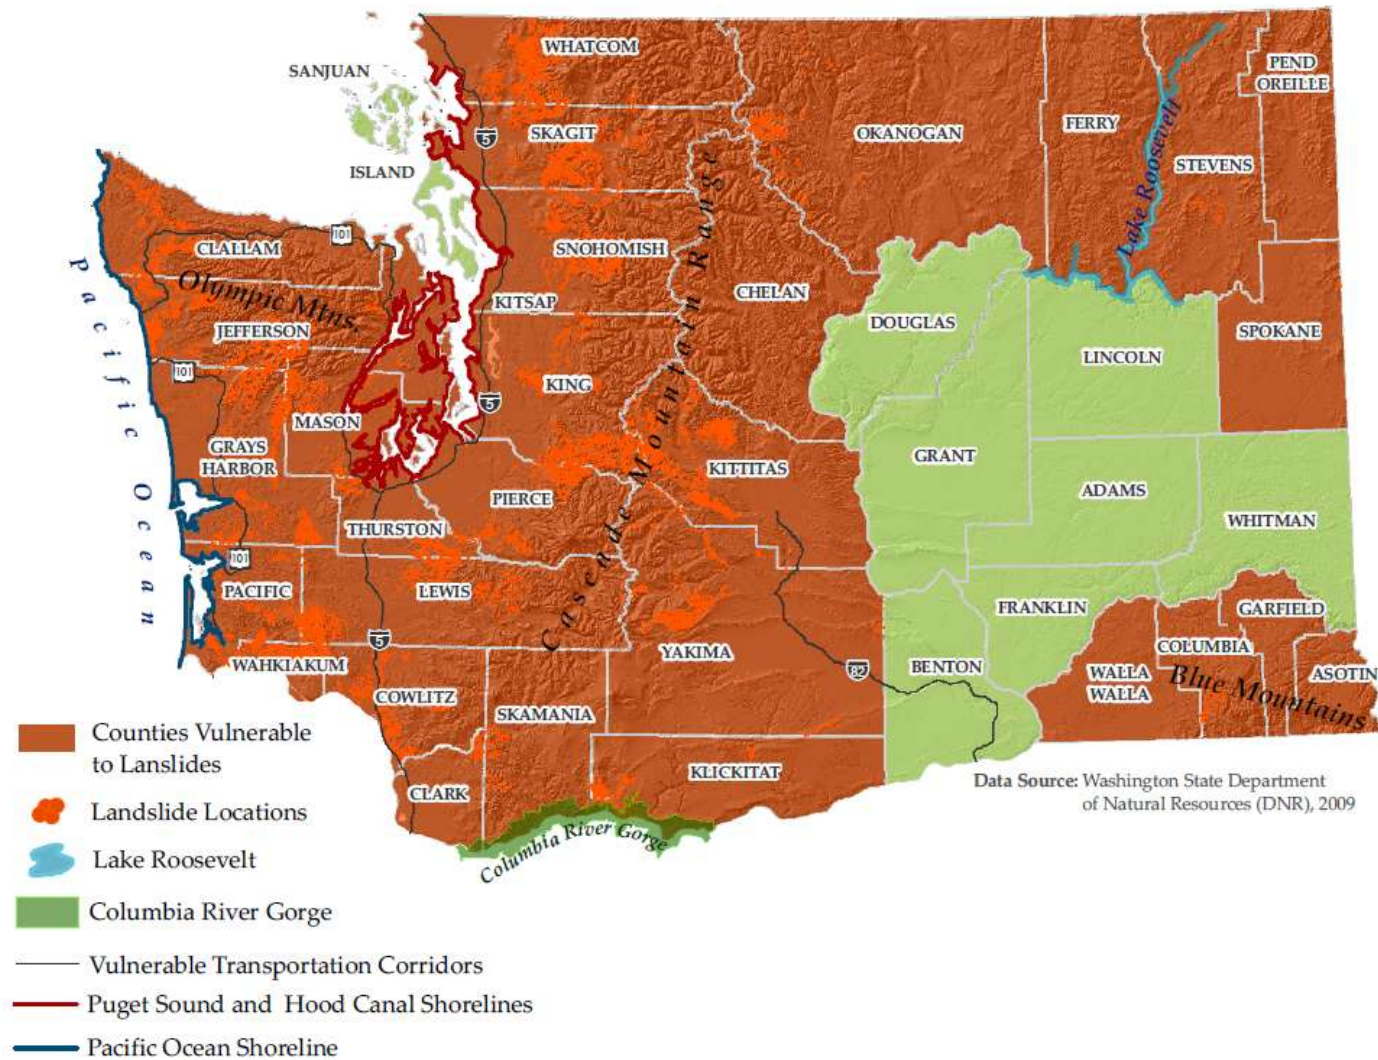
Counties and Areas Vulnerable to Landslides

Figure 7. Counties Vulnerable to Landslide Hazards. Counties within in Washington State that contain known landslides are considered at-risk to future landslide activity.

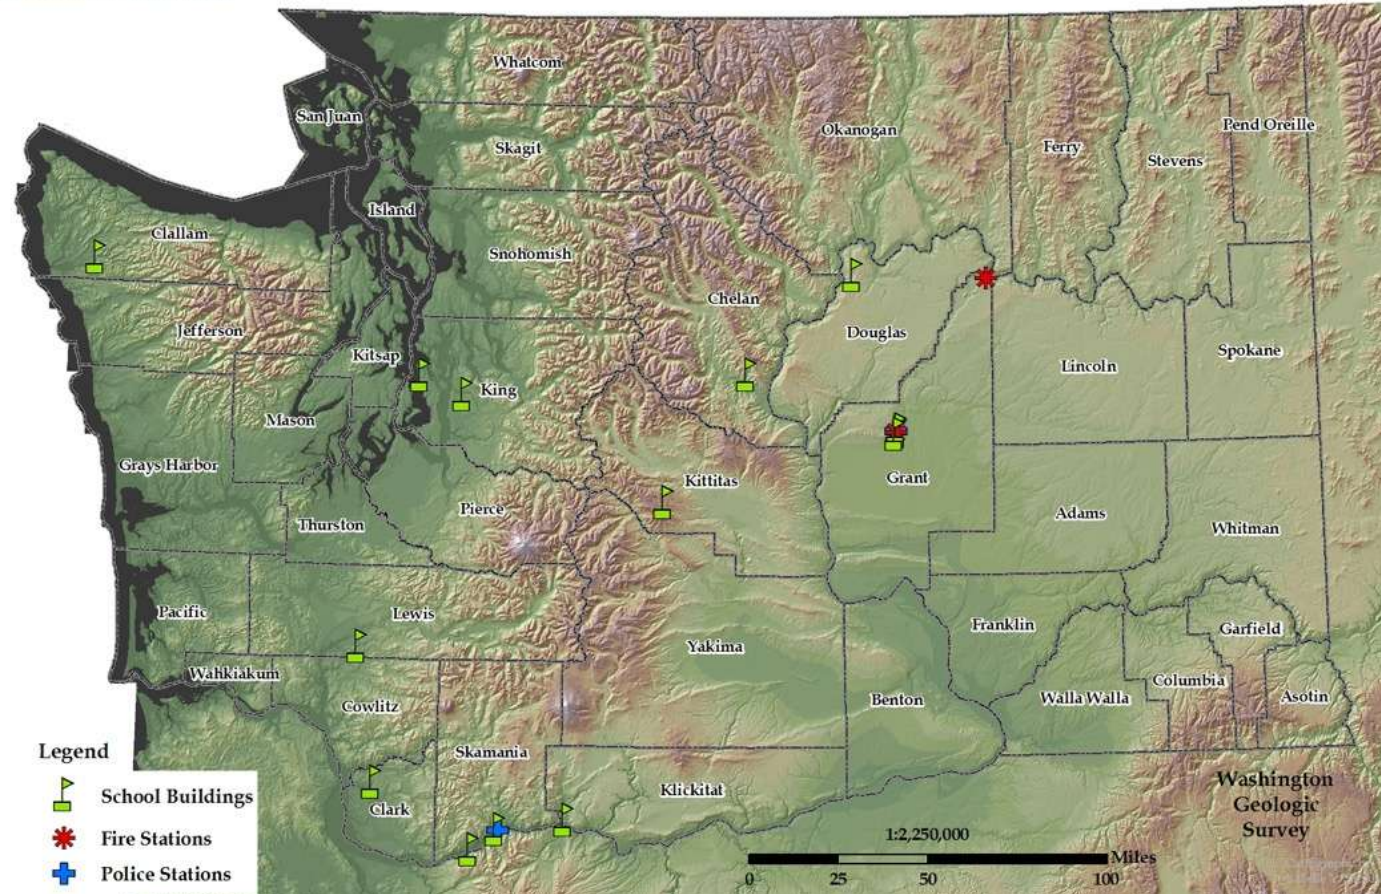
Public Facilities Potentially at Risk to Landslide Hazards

Figure 8. County owned public facilities in or within 100 feet of a landslide within the Washington Geologic Survey's landslide database. These facilities are potentially at risk for future landslide activity

Since no statewide landslide susceptibility map exists, a detailed analysis of public facilities is difficult. However, a simple analysis of public facilities on or nearby landslides indicates 23 facilities potentially at risk of future landslide activity. The risk could include reactivation of a deep-seated landslide or in areas susceptible to shallow landslides, such as debris flows. This simple analysis does not exclude features not shown on the map from landslide risk.

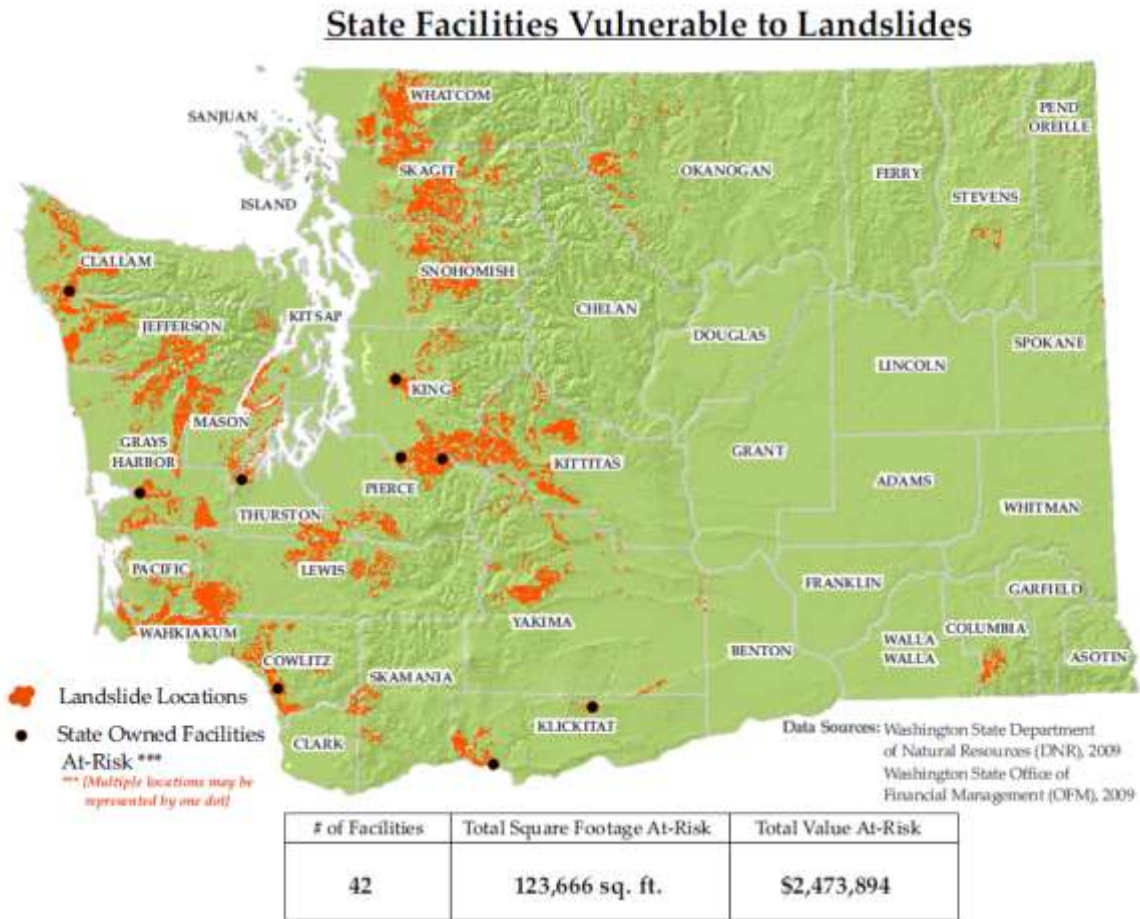
Figure 9. State Owned Facilities within 500 feet a location of a known landslide according to the Washington Geologic Survey's 2009 Landslide Database at 24K.

Utilizing the Washington State Office of Financial Management's 2009 dataset of state leased and owned facilities, an analysis was performed to determine which, if any, state facilities may be at risk to a future landslide. For the state owned facilities in this dataset, 42 were determined to be within 500 feet of a landslide and may therefore be at risk to future landslide activity. These state owned facilities represent over 123,000 square feet of office space with a total value of over \$2.4 million dollars (building stock only, no content). An identical analysis of state leased facilities was performed, but no state leased facilities were determined to be within the specified distance of any known landslide location contained in the landslide database.
